**Annual Inspection carried out at**

**Nursery Road Rec, Barnton**

**on 11<sup>th</sup> June 2026**

**on behalf of Barnton PC**

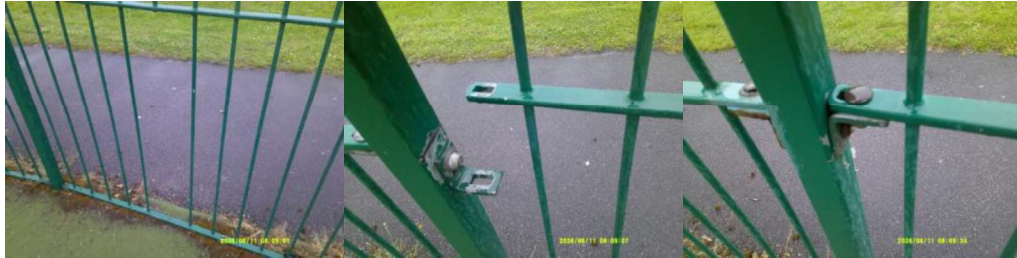
Bow Top Fencing – rails missing – monitor. Posts loose in the ground – secure. Fixings missing – loose panels – replace and secure – all *low risk*.

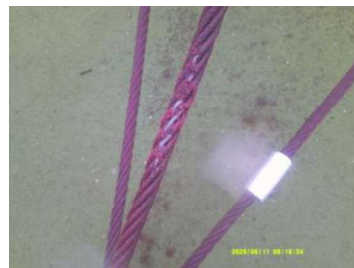
**Rope wear evident – steel cord exposed – low risk - tape up short term.**

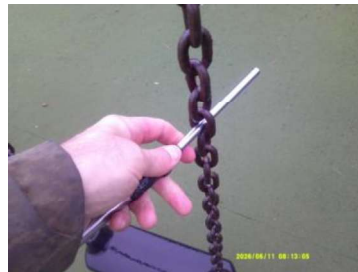
Chain link opening greater than 8.6mm – *low risk* - monitor.

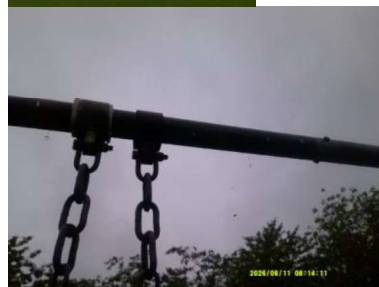
Incorrect splay on the cross beam - anti wrap bearings damaged and moved across the cross beam – *medium risk* - repair and secure to provide the correct splay.

**The assessed LEVEL OF RISK for the play area at the time of the inspection is – MEDIUM (Due to the remnants of the spring rocker left in situ with no hazard tape around it/incorrect splay at the cross beam for the flat swings/anti-wrap bearings damaged).**

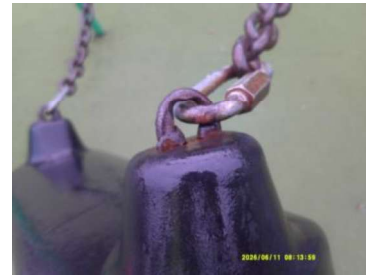
Worn seat lugs – monitor and replace @ 40% wear.

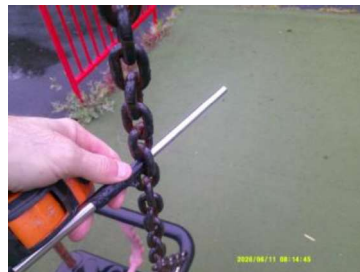
*Chain link opening greater than 8.6mm – low risk - monitor.*

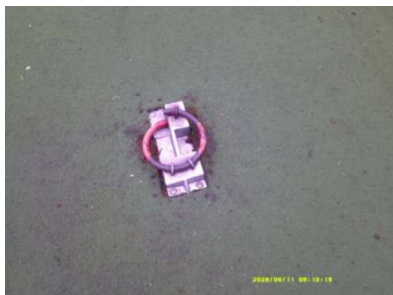
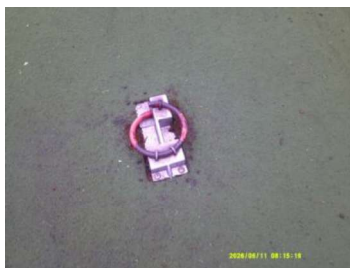
### (6) Spring Rocker – Only base and part of spring in situ.

Only base and part of spring in situ causing trip hazard and sharp edge exposed – *medium risk* – remove or cover with hazard tape until the main body is replaced.

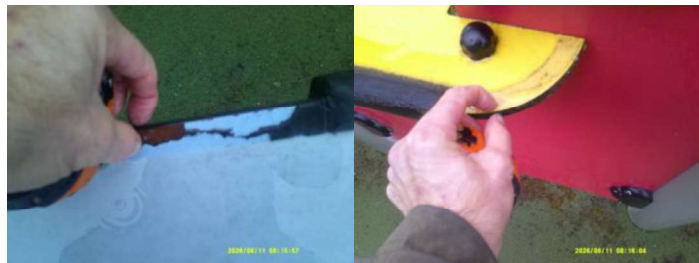
Rubber edging missing across the item – exposed edging less than 3mm radius – *low risk* – replace.

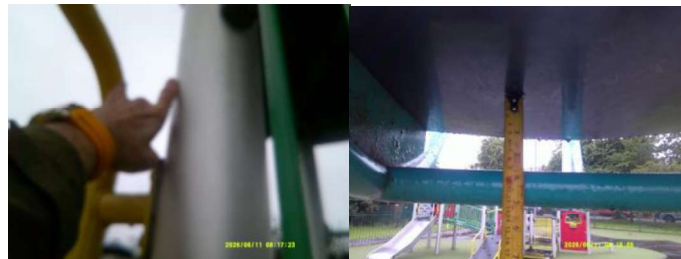
Head/neck entrapments evident – *low risk* - monitor.

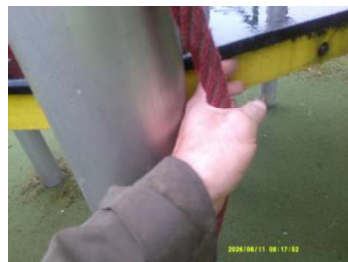
The pull up rope overhangs the support post – crushing/shearing point – *low risk* – monitor.

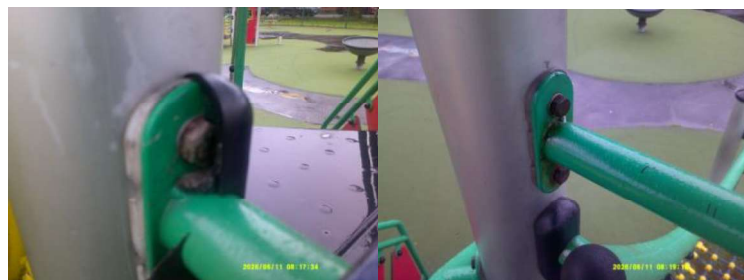
Bracket covers damaged/missing – *low risk* – remove/replace.

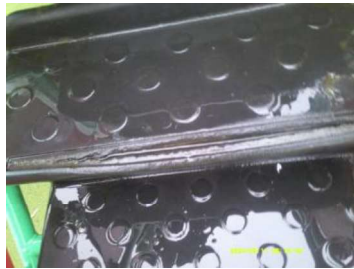
Stairs – rubber covers damaged and split – *low risk* – replace.

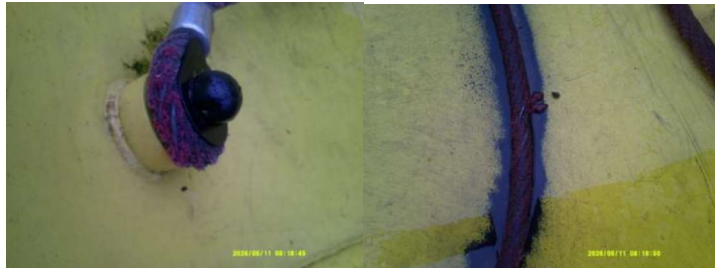
Ropes worn – steel cord exposed – *low risk* – tap up short term.

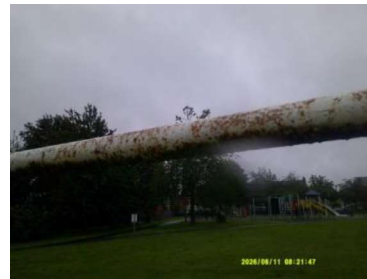
Rust evident – rub down, treat and re-paint.

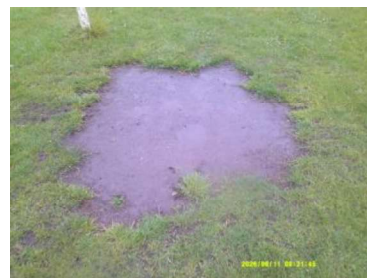
Goal mouths worn – *low risk* – top up soil levels, compact and re-seed.

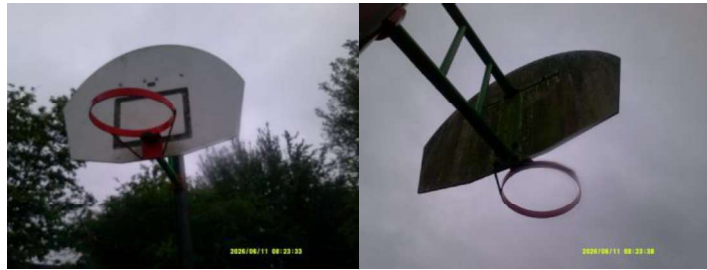
No EN 15312 Warning Sign – *low risk* - monitor.
