**Annual Inspection carried out at**

**Nursery Road Rec, Barnton**

**on 11<sup>th</sup> June 2026**

**on behalf of Barnton PC**

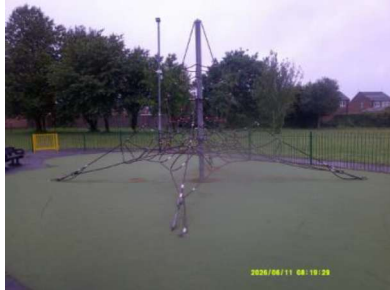
### **(1) Space Net**

The item meets the requirements of BSEN 1176 where this may be tested on site without dismantling or destruction.

**Rope wear evident – steel cord exposed – low risk - tape up short term.**

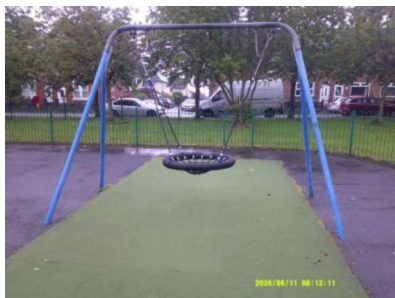
### **(2) Nest Swing**

The item meets the requirements of BSEN 1176 where this may be tested on site without dismantling or destruction.

The item is in good condition and no work is required at this time.

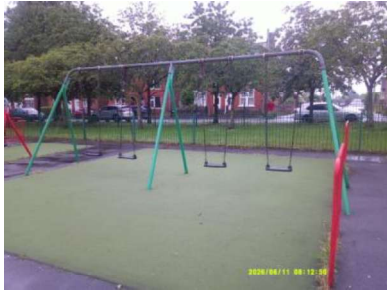
### (3) Swing, 2.4m High, 2 Bay/4 Seat (Flat)

The item fails to meet the requirements of BSEN 1176 in the following respect:

Chain link opening greater than 8.6mm – *low risk* - monitor.

Incorrect splay on the cross beam - anti wrap bearings damaged and moved across the cross beam – *medium risk* - repair and secure to provide the correct splay.

Worn seat lugs – monitor and replace @ 40% wear.

**The assessed LEVEL OF RISK for the play area at the time of the inspection is – MEDIUM (Due to the remnants of the spring rocker left in situ with no hazard tape around it/incorrect splay at the cross beam for the flat swings/anti-wrap bearings damaged).**

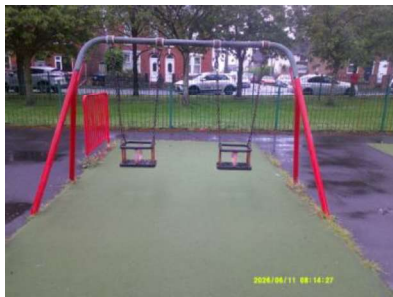
**(4) Swing, 1.8m High, 1 Bay/2 Seat (Cradle)**

The item fails to meet the requirements of BSEN 1176 in the following respect:

*Chain link opening greater than 8.6mm – low risk - monitor.*

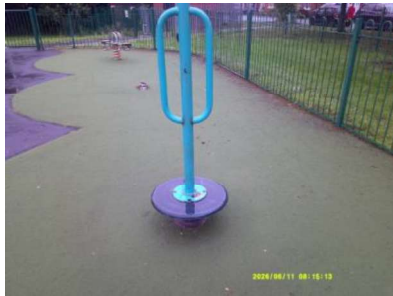
### (5) Pole Spin

The item meets the requirements of BSEN 1176 where this may be tested on site without dismantling or destruction.

The item is in good condition and no work is required at this time.

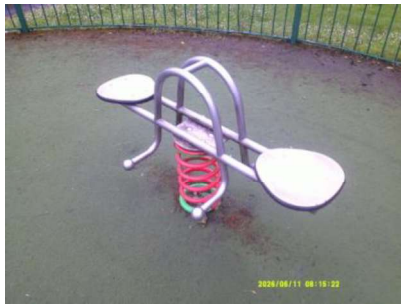
### (7) Spring Seesaw

The item meets the requirements of BSEN 1176 where this may be tested on site without dismantling or destruction.

The item is in good condition and no work is required at this time.

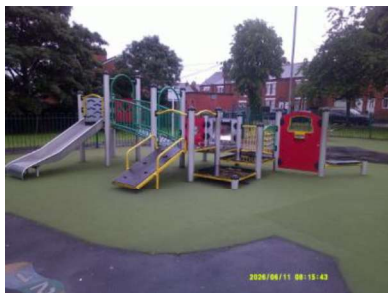
### (8) Toddlerzone Multi-Play Unit

The item fails to meet the requirements of BSEN in the following respect:

Rubber edging missing across the item – exposed edging less than 3mm radius – *low risk* – replace.

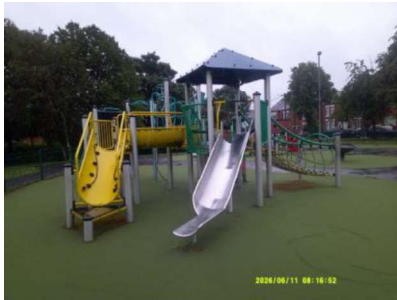
### (9) Playzone Multi-Play Unit

The item fails to meet the requirements of BSEN 1176 in the following respect:

Head/neck entrapments evident – *low risk* - monitor.

The pull up rope overhangs the support post – crushing/shearing point – *low risk* – monitor.

Bracket covers damaged/missing – *low risk* – remove/replace.

Stairs – rubber covers damaged and split – *low risk* – replace.

Ropes worn – steel cord exposed – *low risk* – tap up short term.

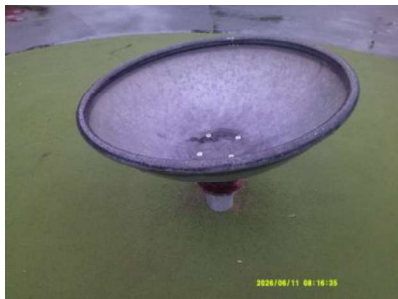
**(10) Dish**

The item meets the requirements of BSEN 1176 where this may be tested on site without dismantling or destruction.

The item is in good condition and no work is required at this time.

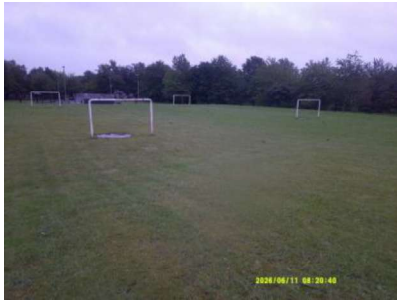
## (11) Goal Posts

Rust evident – rub down, treat and re-paint.

Goal mouths worn – *low risk* – top up soil levels, compact and re-seed.

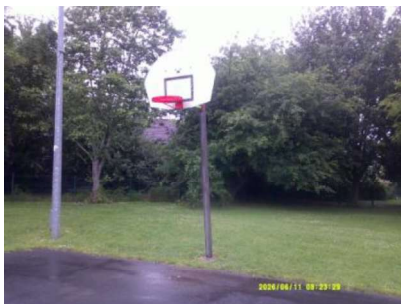
## (12) Basketball Post

The item fails to meet the requirements of BSEN 15312 in the following respect:
